Audit - Photos Report			
Factory Name	Anji Maochang Furniture Co., Ltd.	Audit type	Full audit
Eurofins CPA Office	China	Audit date	November 10, 2025
Customer	Amfori BSCI	Report number	CH_AJMCF_1

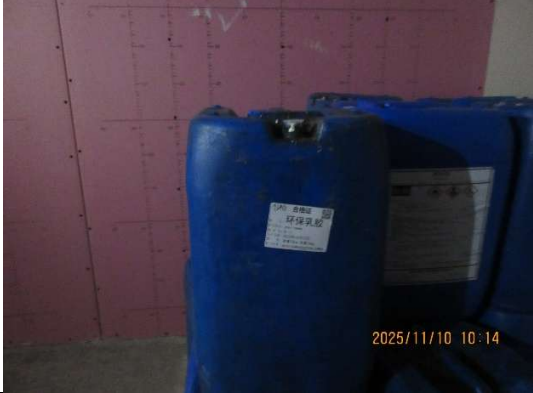
Comments:	Comments: Finding: PA 7.7 Missing safety label for glue	Comments: Finding: PA 7.17 Needle guard equipped too high to protect employees' finger
-----------	---	--
