Audit - Photos Report			
Factory Name	Anji Maochang Furniture Co., Ltd.	Audit type	Full audit
Eurofins CPA Office	China	Audit date	November 10, 2025
Customer	Amfori BSCI	Report number	CH_AJMCF_1

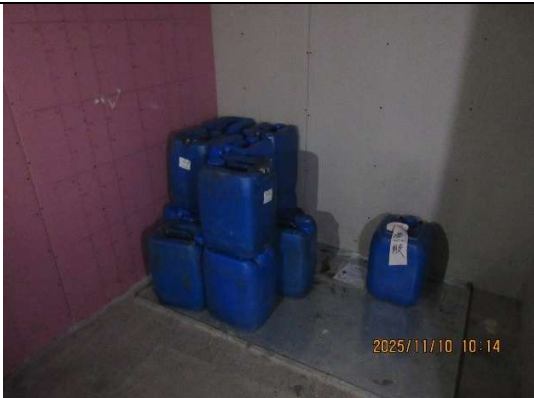
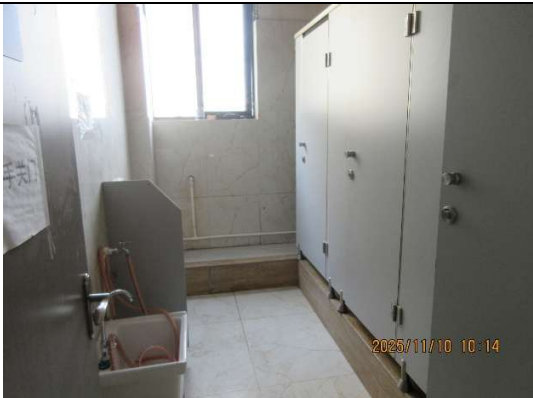
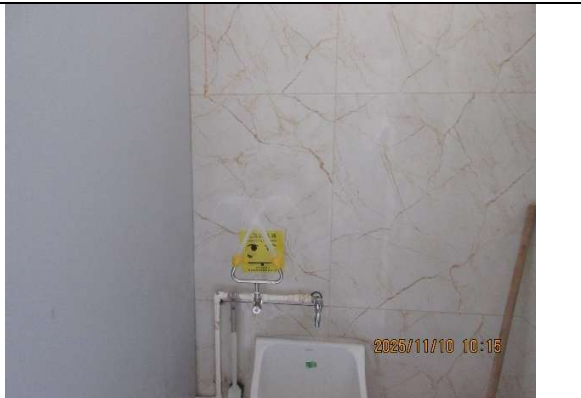
<p>Description/Area: Chemical warehouse</p>	<p>Description/Area: Toilet</p>	<p>Description/Area: Eye washing facility</p>
<p>Comments:</p>	<p>Comments:</p>	<p>Comments:</p>
